TECHNICAL INFORMATION

TASCAM SX-1/DM-24, Change of Capacitors on SW PSU

No. **0304R**DATE 04th Mar 2003

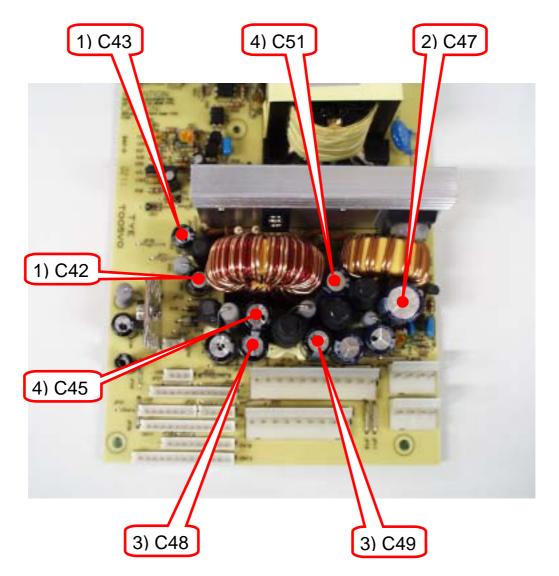
The New SW PSU identification "01" or "02" is stamped here.

* Early reworked SW PSU has no "01" or "02" mark. A sign of rework can be identified in case the C45 and C51 have an orange color sleeve fitted.
